RDT&E Project No. Not Available  
USATECOM Project No. 1-6-4030-12  
Report No. DPS-2309

FINAL REPORT ON  
PRODUCT IMPROVEMENT TEST  
OF  
TRUCK, UTILITY, 1/4-TON, 4X4, M151, MODIFIED  
WITH SOLID REAR AXLE  
BY  
C. M. BRYZEK, JR.  
MARCH 1967

12 APRIL THROUGH 30 DECEMBER 1966

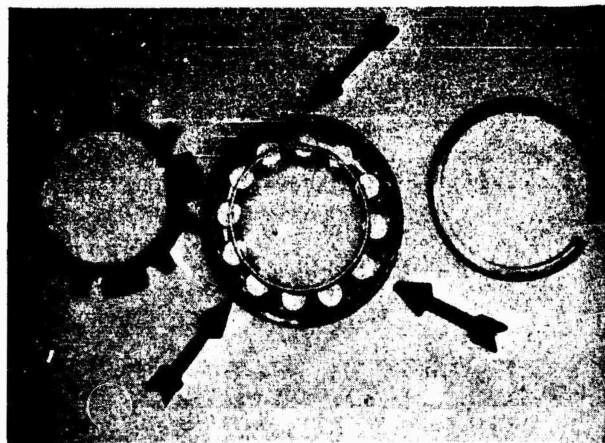
Examination of the rear axle assembly after completion of the durability test disclosed that the snap-ring groove in the pinion shaft pilot bearing was broken off around the circumference of the bearing (Figure 2.11-6).

Figure 2.11-6: Snap-Ring Groove Broken Off Pinion-Shaft Pilot Bearing.
